TM 4967:70-616

DATE 24 February 1970

TECHNICAL MEMORANDUM

TITLE: Operation and Post-Test Inspection of the SNAP-8
Pre-Prototype Boiler P/N CF 751840, S/N 2

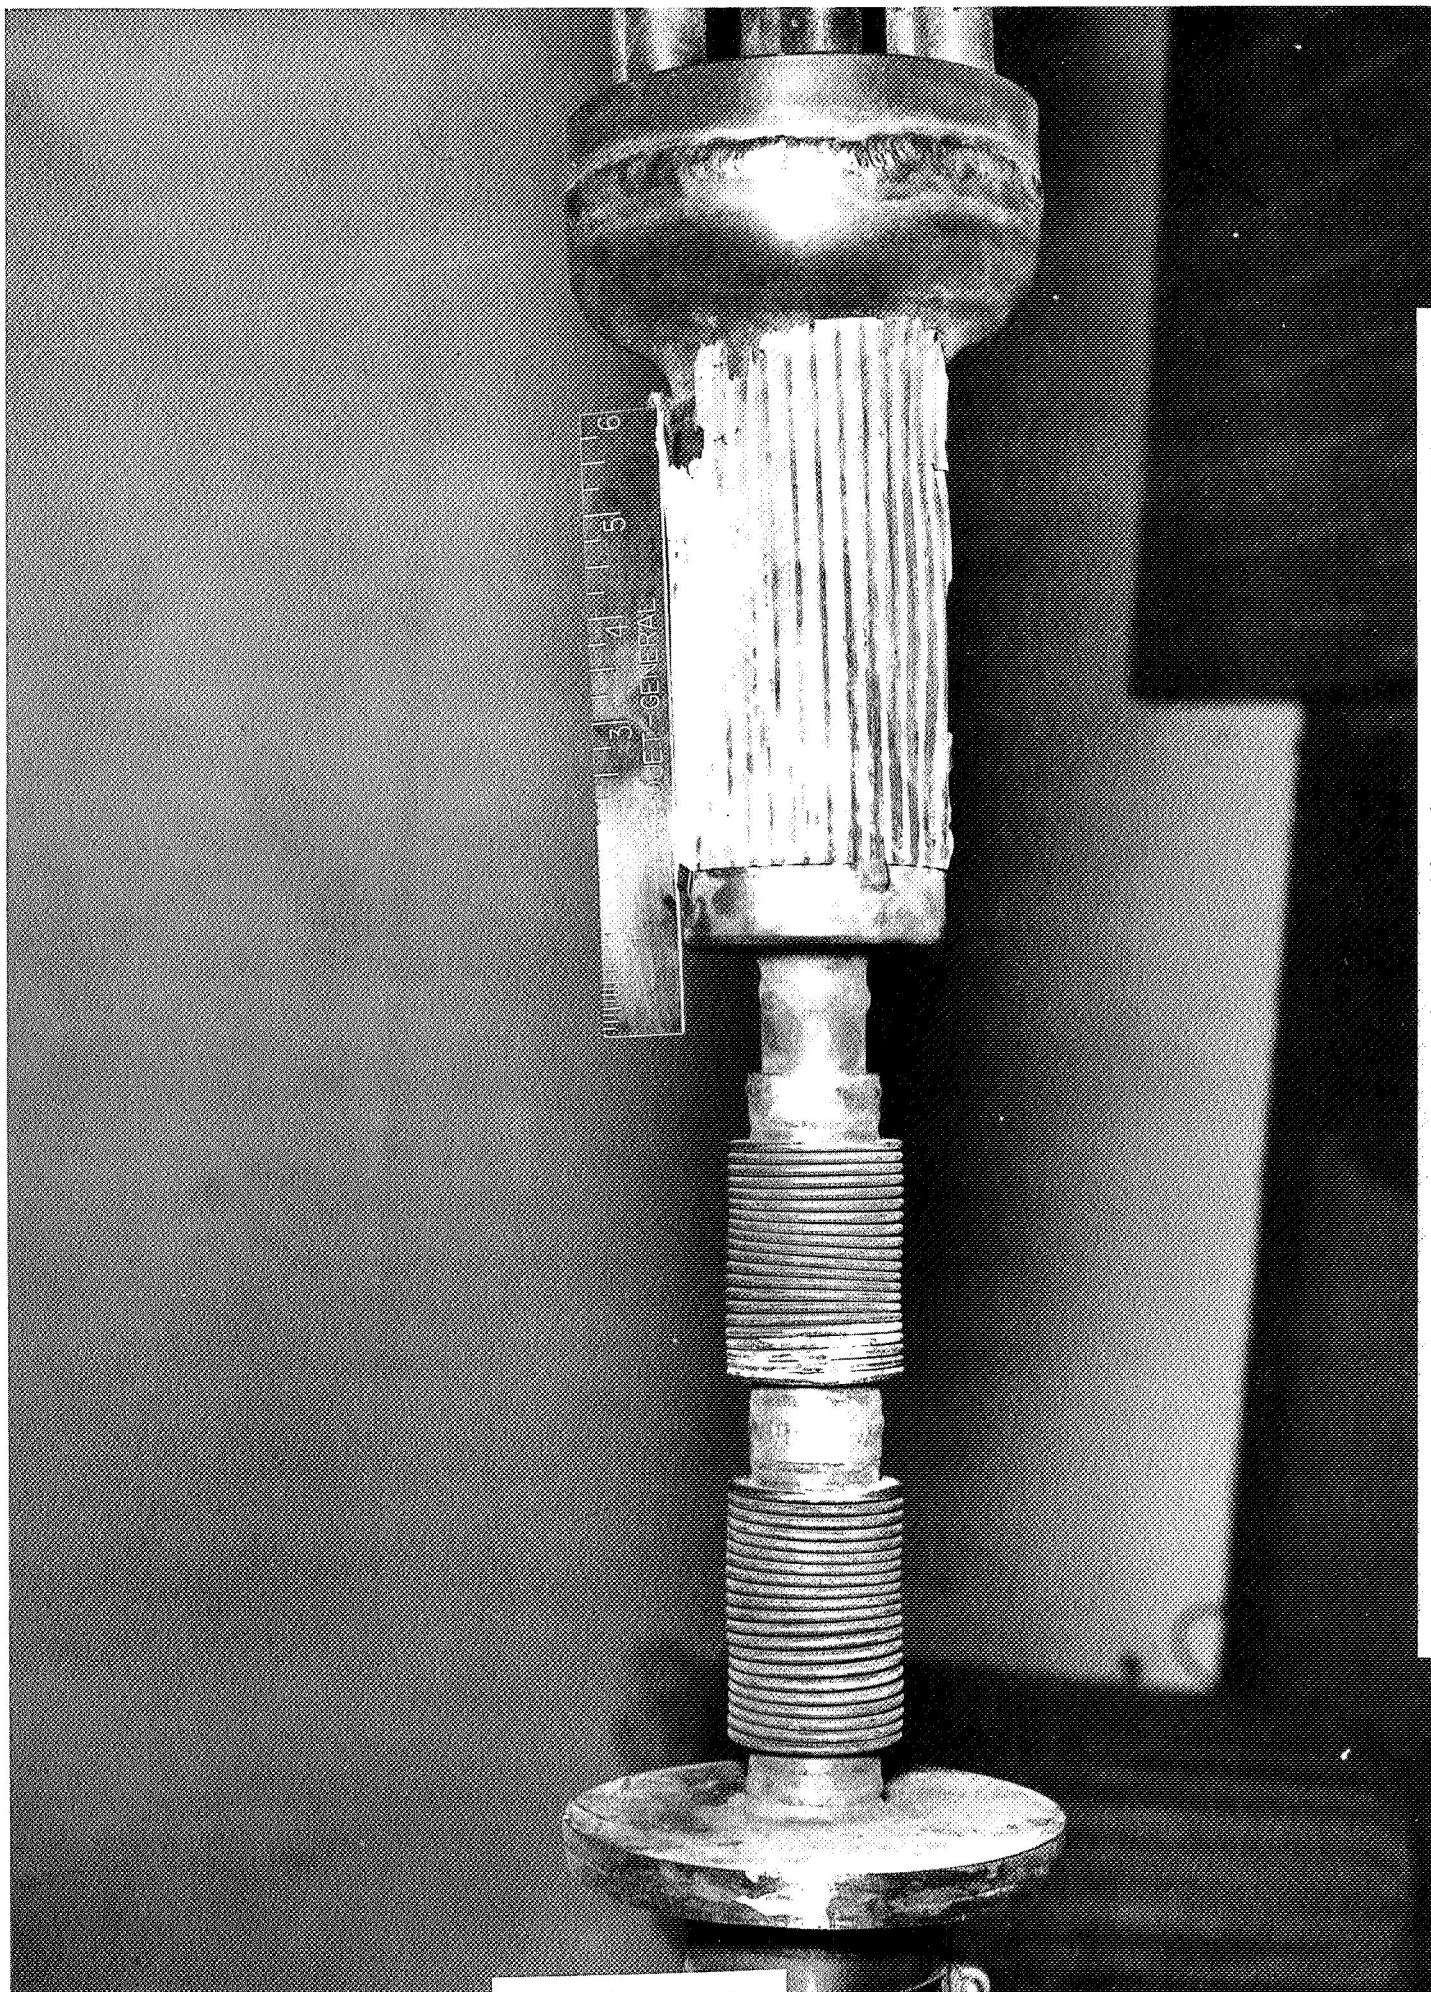
Figure 12 - The mercury inlet bellows, the zirconium corrugated foil and the tantalum dome can be seen in this photo. Some squirming can be seen in the bellows but this was present when they were originally installed. They are shown in the collapsed position because that is their attitude when the boiler is cold. When the boiler heats up, the bellows extend approximately one-half inch, as measured during test. The zirconium foil was badly decomposed and fragmented. The analysis of the foil for oxygen, hydrogen, and carbon is shown in Appendix B. The tantalum dome appeared to be in excellent condition.

The purpose of the zirconium foil is to primarily gather oxygen from the static NaK to prevent oxidation of the tantalum surfaces, especially, in the region of the transition joint. From Figures 12 and 14, it is evident that the zirconium at the Hg inlet is much more contaminated than that at the Hg outlet. Samples of the foil from both ends of the boiler were chemically analyzed for carbon, hydrogen, nitrogen, and oxygen.

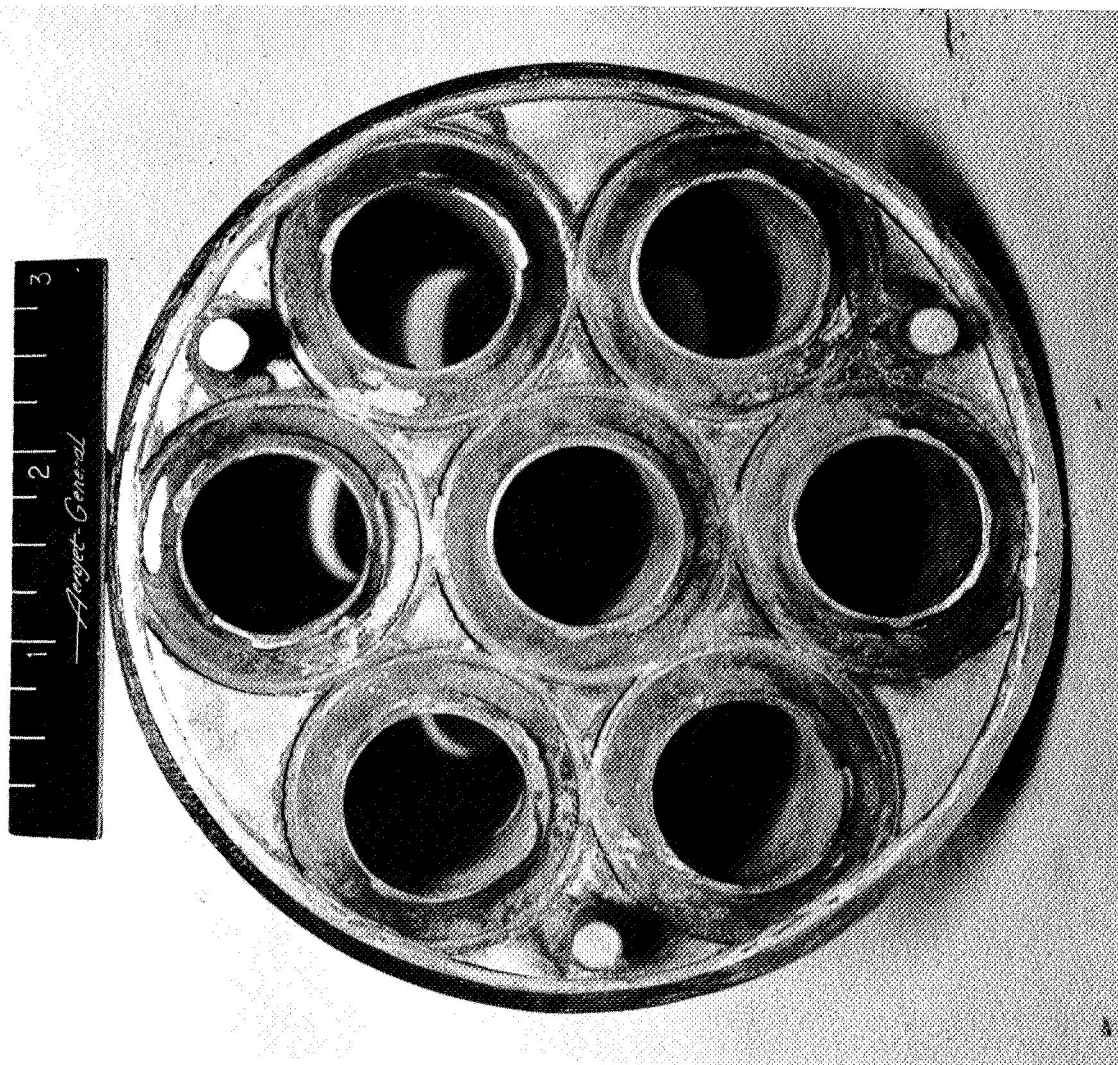
Figure 23

Removal of the Tantalum and Type 316SS headers from the Hg inlet was the last step in the boiler disassembly procedure. To separate the headers, the tube bundle was cut at a point such that the remaining plug insert length left in the boiler would be four feet. A front view of the 316SS header is shown in Figure 23. All of the tube-to-header welds were inspected and found to be free of defects. The three pins spaced 120° apart had been installed to prevent the two headers from contacting each other and to prevent over-extension of the tandem bellows. Figure 24 is a photograph of the boiler in its present state.

316 SS HEADER-TO-321 SS TUBE WELDS REMOVED FROM BOILER
P/N CF751840-9/2 AFTER 8700 HOURS OF OPERATION
